1. GENERAL

This document is a short version and an extract from the “Instruction for filling and periodic inspection” for the Hexagon Ragasco composite LPG cylinders, adjusted to fit specific US requirements.

HEXAGON
RAGASCO

SHORT GUIDE TO RETESTING COMPOSITE LPG CYLINDERS
01 July 2013

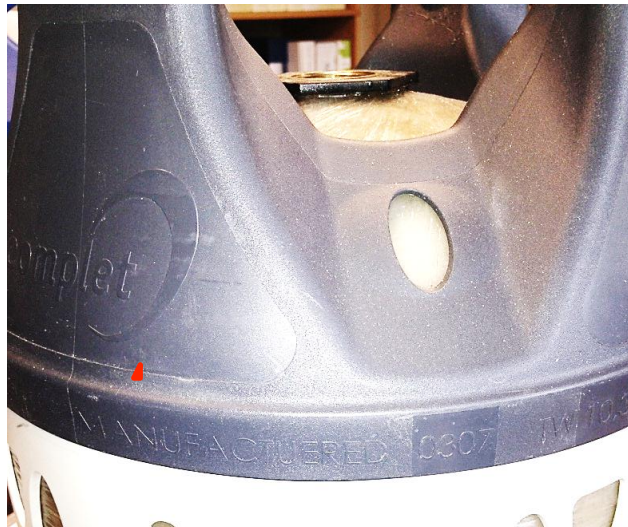
Picture 3.1.2a – Marking at the front of the casing shows when the cylinder was produced. Marking format is month, year, MMY. Circled in red.

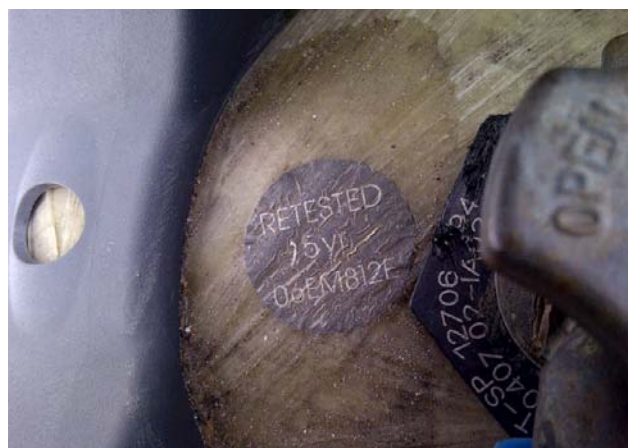
Picture 3.1.2b – Example of requalification label epoxied to cylinder. Contains RIN/VIN and Month & Year of test.

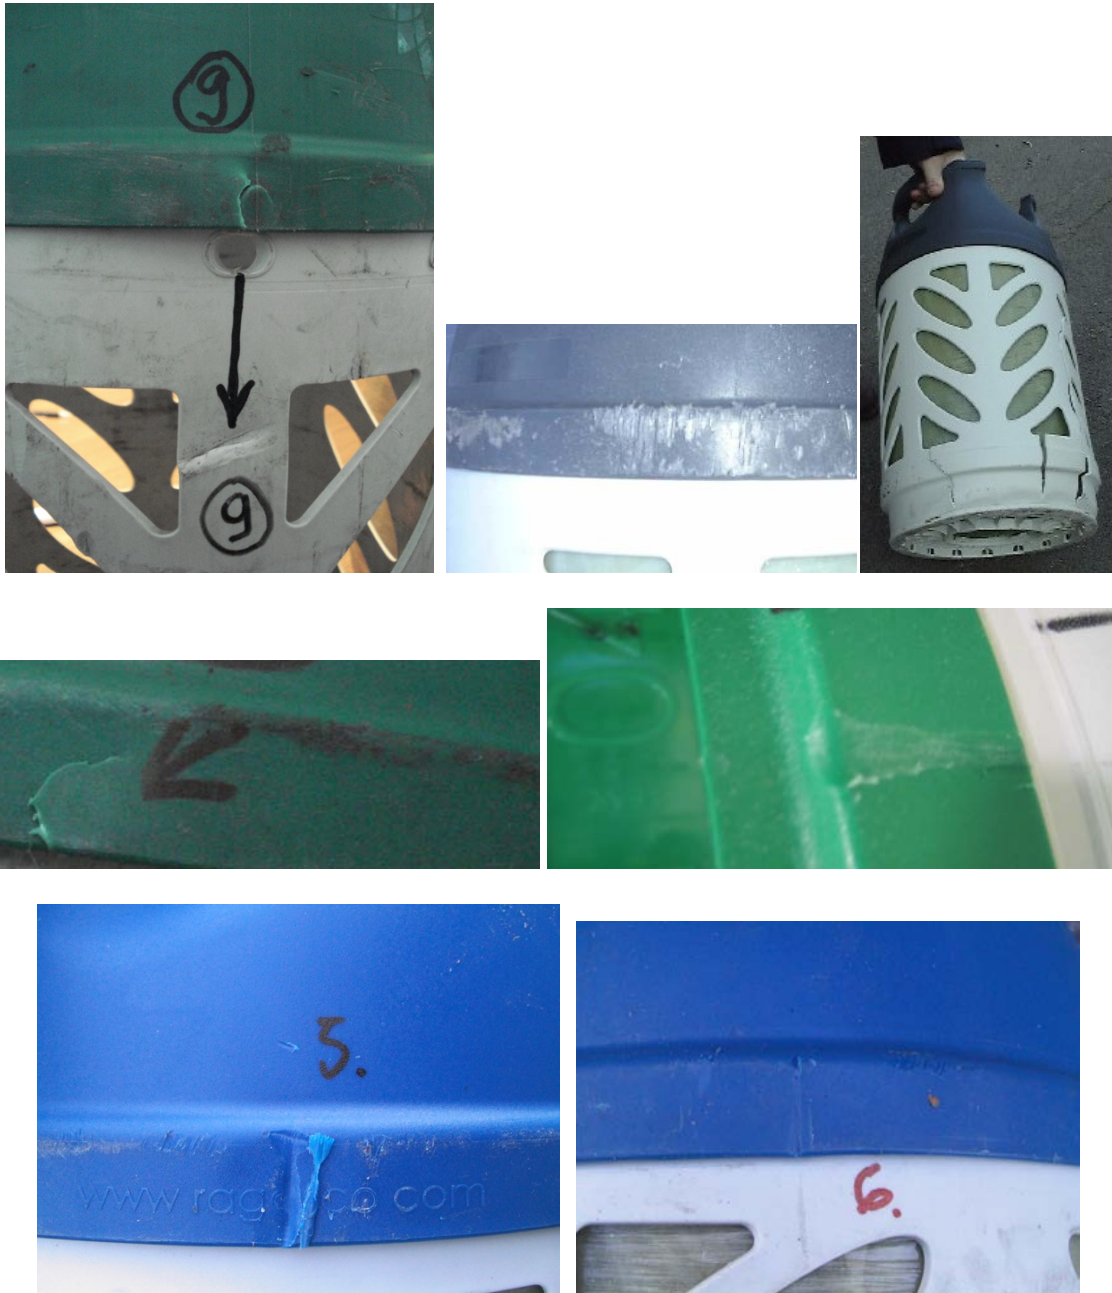
Figure 1a — Damage on casing “skirt”— not acceptable

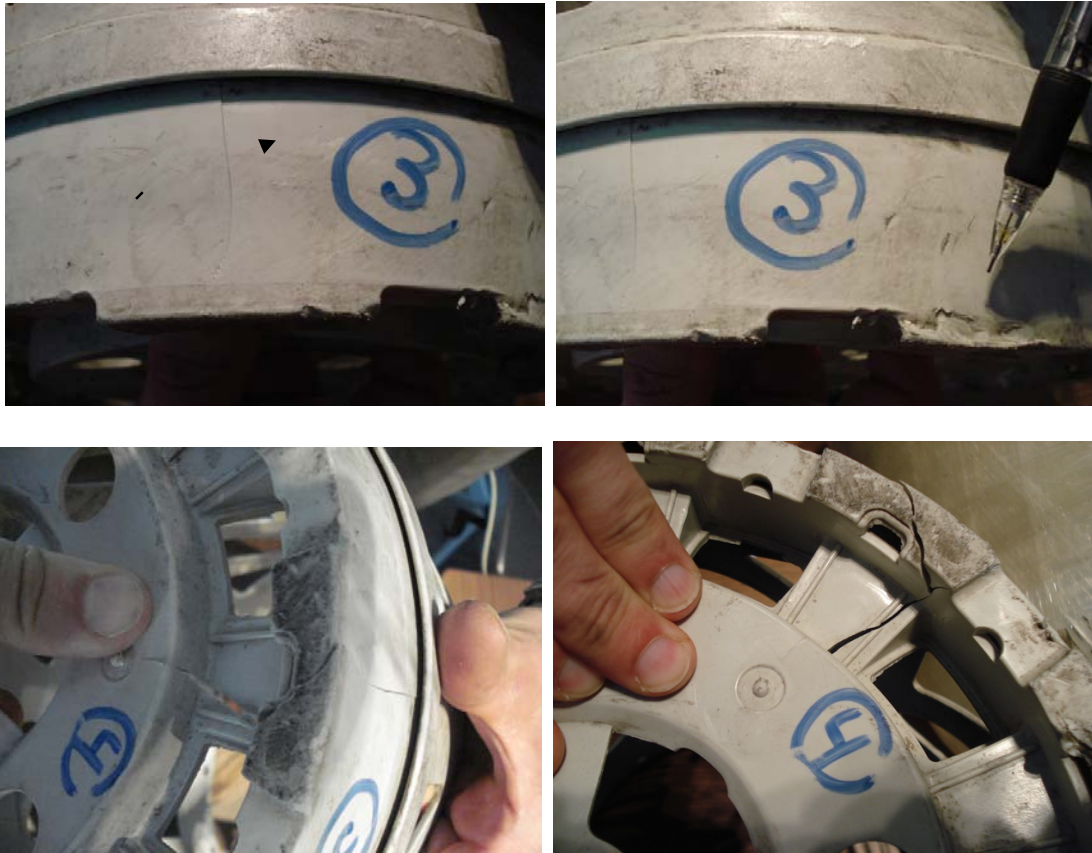
Figure 1b — Damage on casing base – not acceptable

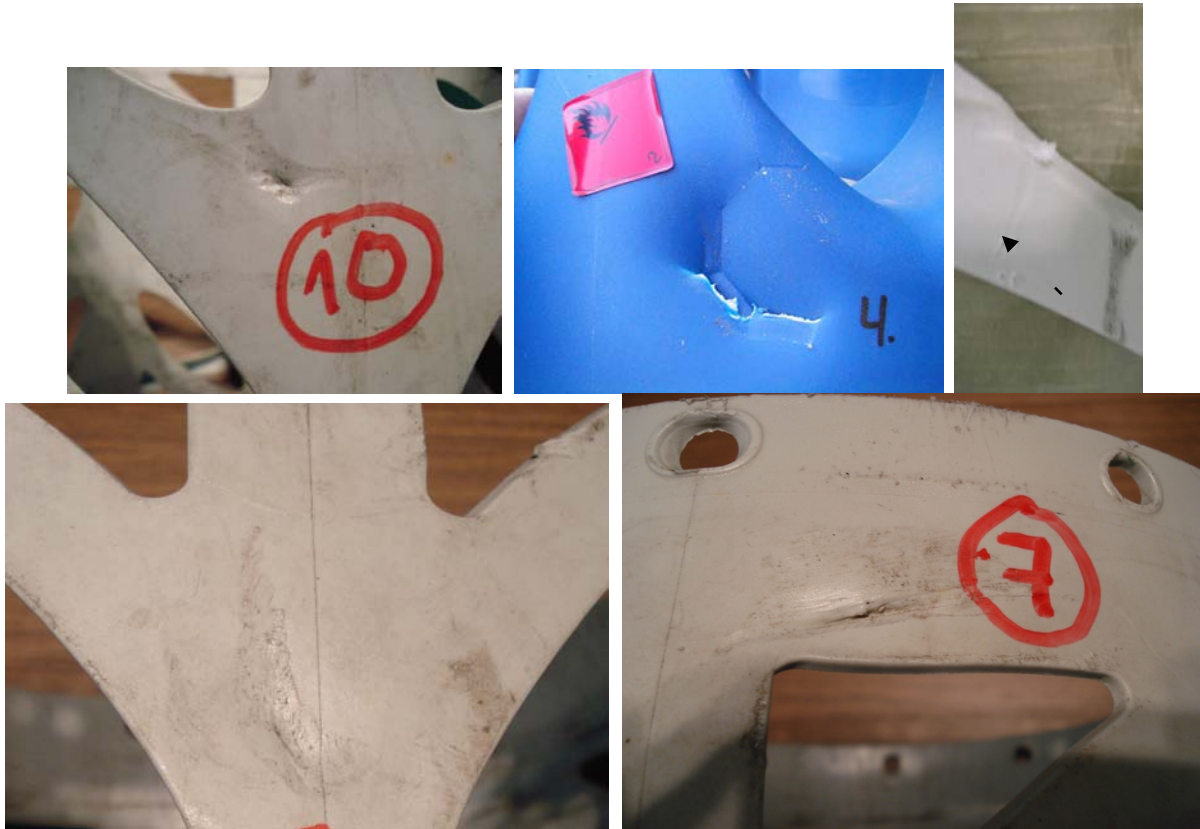
Figure 1c — Damage on casing cylindrical area – not acceptable

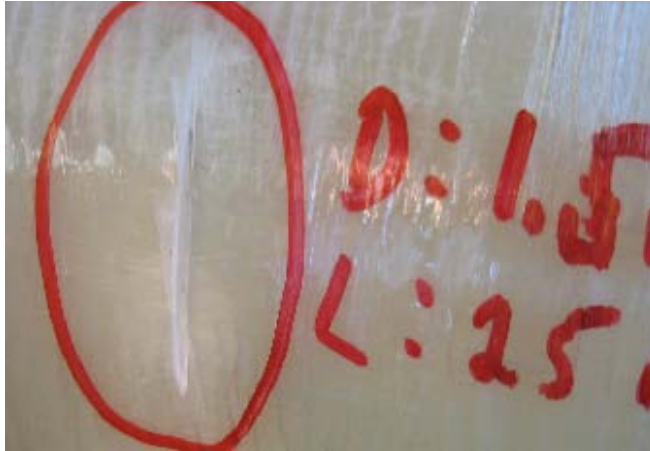
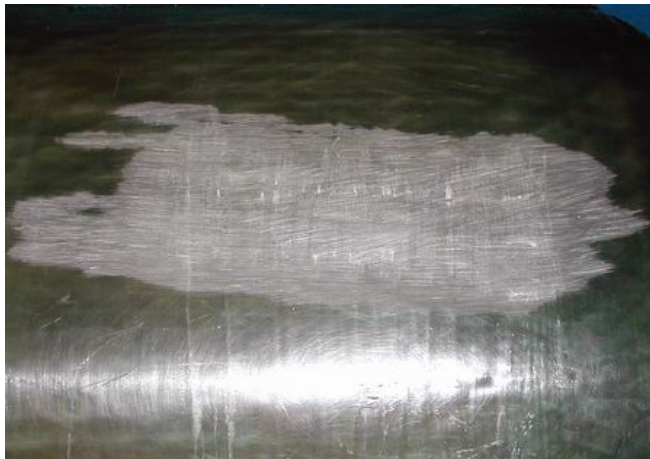
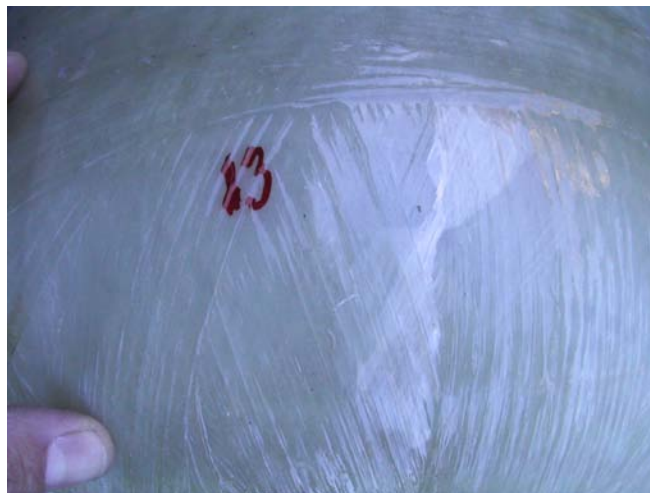
Type of damage	Description	Rejection if
Abrasion damage or damage from cuts.	<p>Abrasion damage caused by wearing, grinding or rubbing material away by friction.</p> <p>Cuts or gouges caused by contact with sharp objects in such a way as to cut into the composite, reducing its thickness at that point,</p>	<p>Casing damage:</p> <ul style="list-style-type: none"> Any small and large damage to the upper casing “skirt” typical $>20\text{mm}^2$, depending on depth and mode Cuts/cracks to the lower casing base Abrasion / cut through casing Total length of non-penetration cuts $>50\%$ diameter of the cylinder Total damaged area maximum diameter is more than 50 % of the diameter of the cylinder (note 1) <p>See Figure 1</p> <p>Composite damage:</p> <ul style="list-style-type: none"> Any cut or otherwise damaged fibre <p>See Figure 2</p> <p>Note 1: the maximum diameter of the damage area is the diameter of the smallest circle that includes the damaged area. Note 2: Intra-laminar hairline cracks (between fibres, typically on the circumference after proof testing) are allowed if not in combination with impact damage. Note 3: Scratches that do not sever a fibre are not included in the above.</p>

Figure 2 — Damage from abrasion and cuts— not accepted

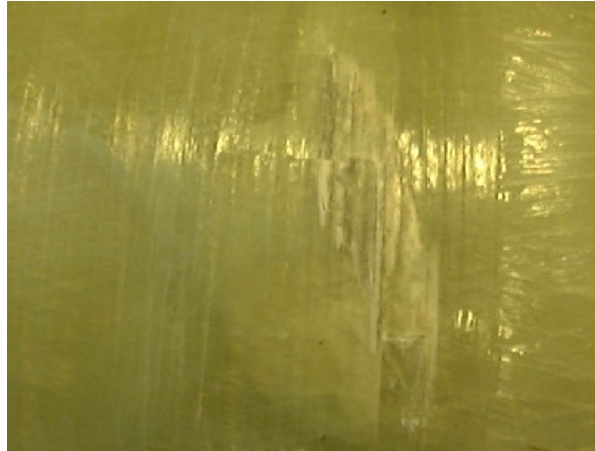
Delamination and impact damage	<p>Impact damage may appear as hairline cracks in the resin or delamination or cuts of the composite material.</p> <p>It may also appear as a whitish patch like a blister or air bubble beneath the surface.</p>	<ul style="list-style-type: none"> Any delamination in combination with surface damage, Cut fibres. Delamination covering more than 50 % of the cylinder. <p>See Figure 3</p> <p>Note 4. Areas with no adhesion between liner and over wrap shall not be regarded as delaminated. Note 5. Inter-laminar delamination is separation of layers of strands. Intra-laminar delamination is separation between strands within the same layer.</p>
Chemical damage	Chemical attack appearing as the dissolution of the resin matrix surrounding the fibres, where the cylinder is sticky. [text removed]	The cylinder shall be rendered unserviceable.

Figure 3a — Impact damage in combination with delamination and surface defects – not acceptable

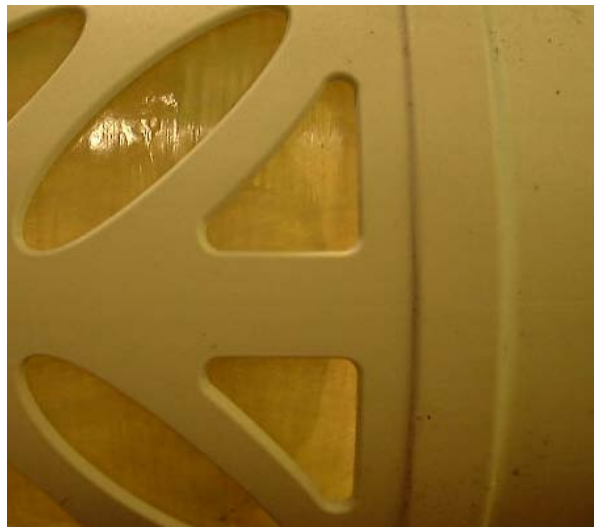
Figure 3b — Delamination and no surface damage - acceptable

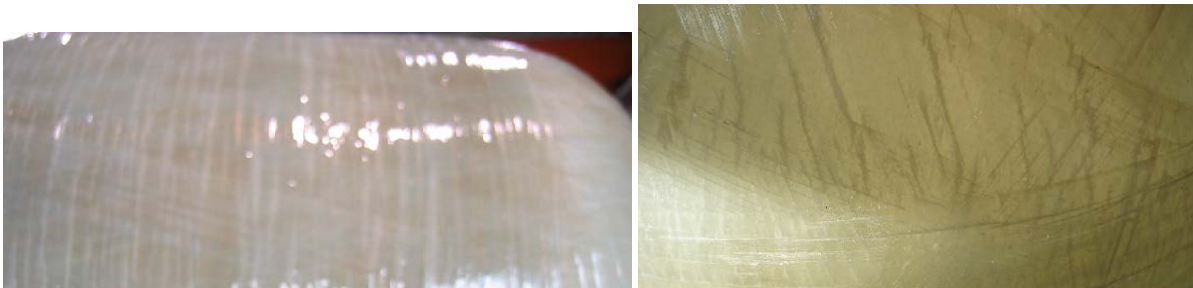
**Figure 3c — Intra-laminar lamination due to pressure cycling >12000 cycles to proof pressure
- not acceptable damage, even though burst pressure is still above 90 bars.
If less than approximately 100 hairlines, it is acceptable.**

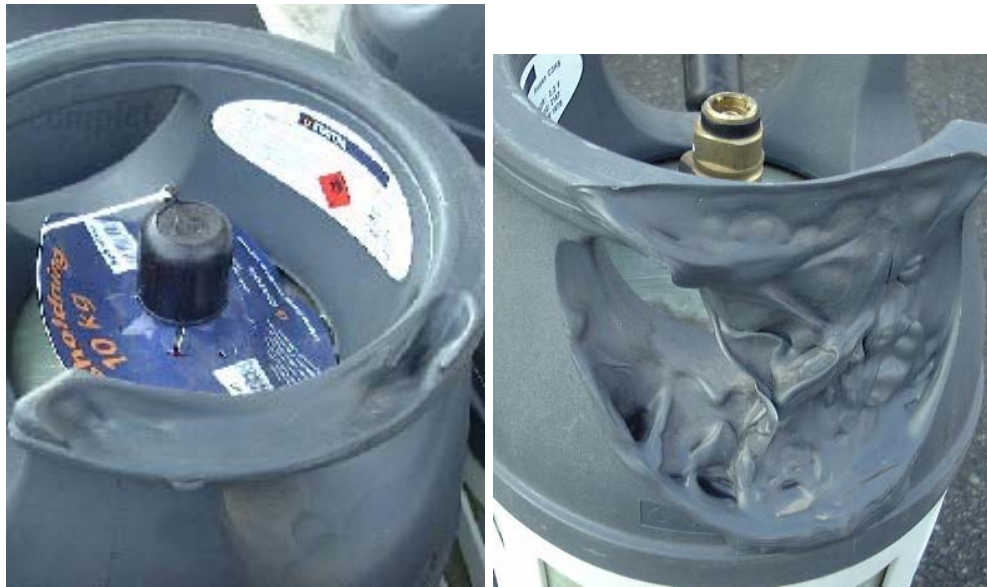
Heat/fire damage of the casing or composite	Heat or fire damage evident by discolouration, scarring or burning of the composite overwrap, casing, labels and non-metallic components of the valve.	Visible damage from heat and/or fire. Cylinders with this type of damage shall be rendered unserviceable. See Figure 4 .
---	--	---

Figure 4 — Heat damage. This type of damage is not acceptable in any form
